## CONTINUING ELIGIBILITY INSPECTION (CEI) REPORT

FOR FLOOD CONTROL WORKS

Honolulu Engineer District

1. Project Name: Iao Stream FCP
2. Date of Inspection: November 2, 2005
3. Inspection Personnel:

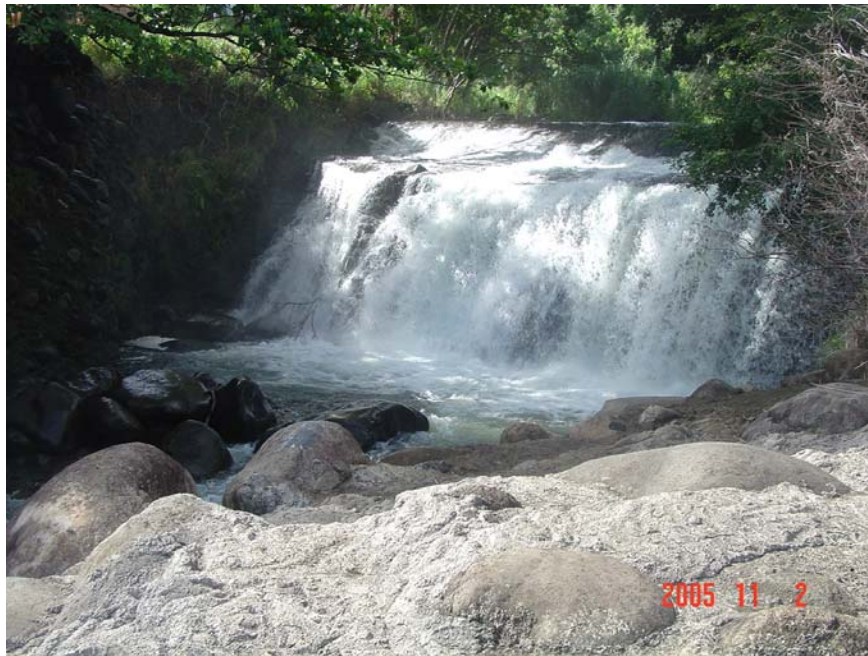
a. Sta. 135+00, Left Bank (LB), upstream of the debris basin, overview of the grouted rock slope protection.

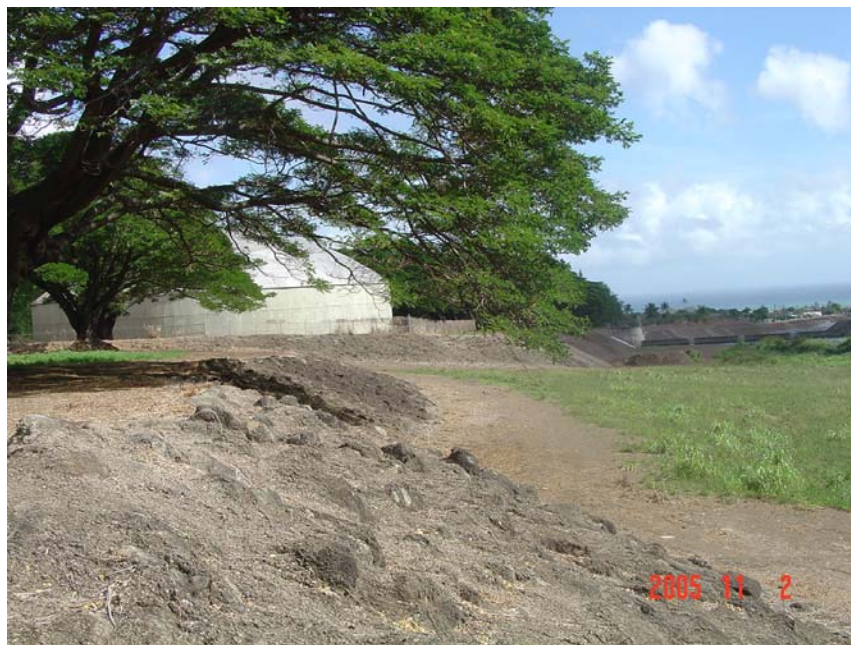
b. Sta. 130+50, LB, Overview of Levee I, and debris basin. Remove vegetation from top of Levee. Remove castor bean tree on the sideslope.

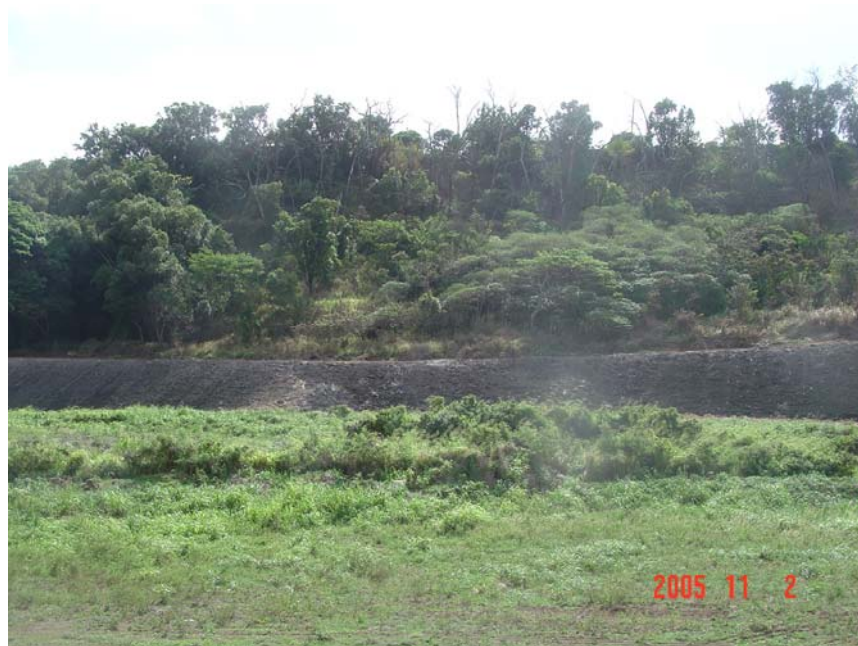
c. Sta. 133+00, Right Bank (RB), vegetation removed from sideslope.

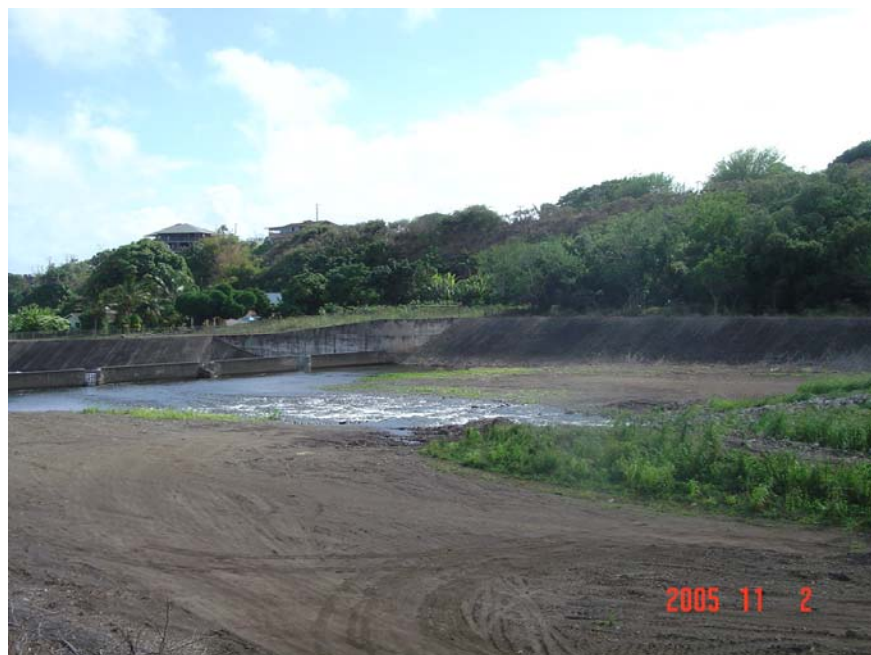
d. Sta. 127+00, RB, remove vegetation from toe of sideslope.

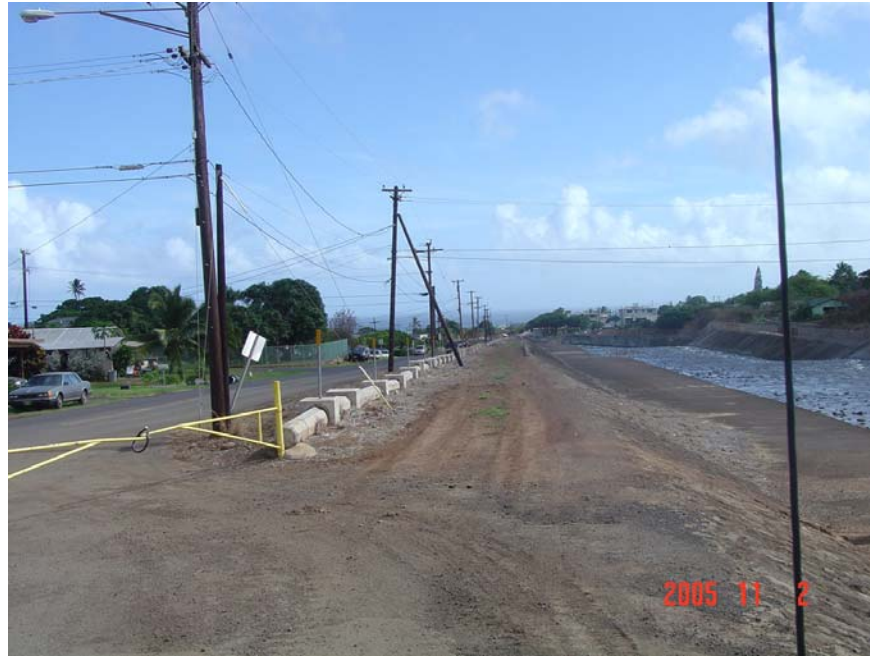
e. Sta. 119+00, LB, Overview of levee.

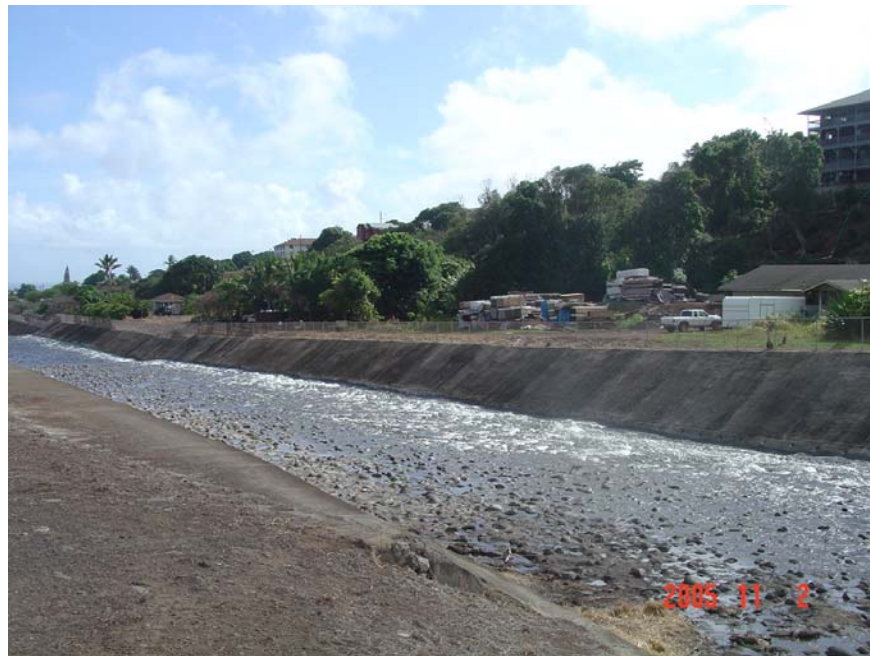
f. Sta. 119+00, RB, vegetation removed from top of sideslope and weep holes clean.

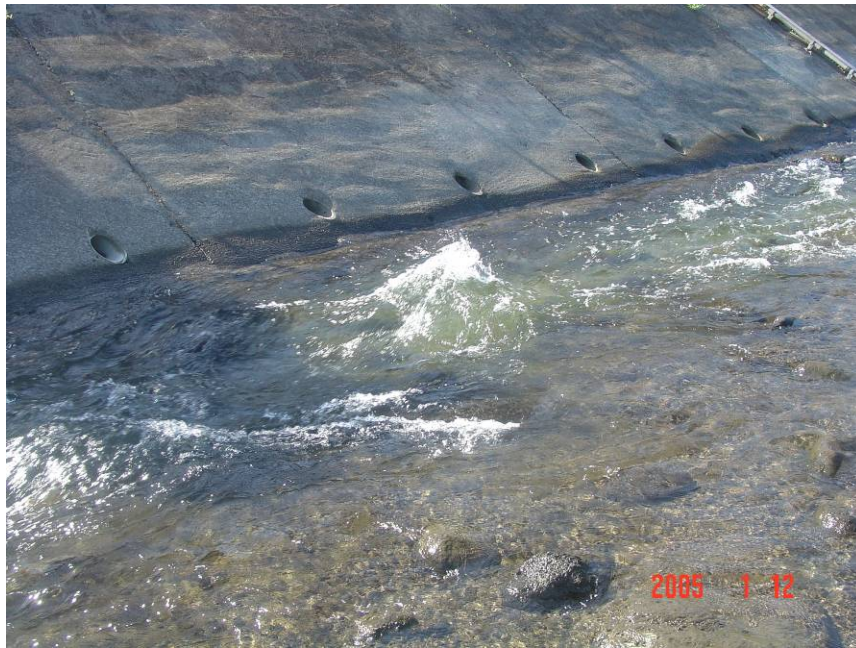
g. Drop Apron #2, verify invert condition in low flow, RB.

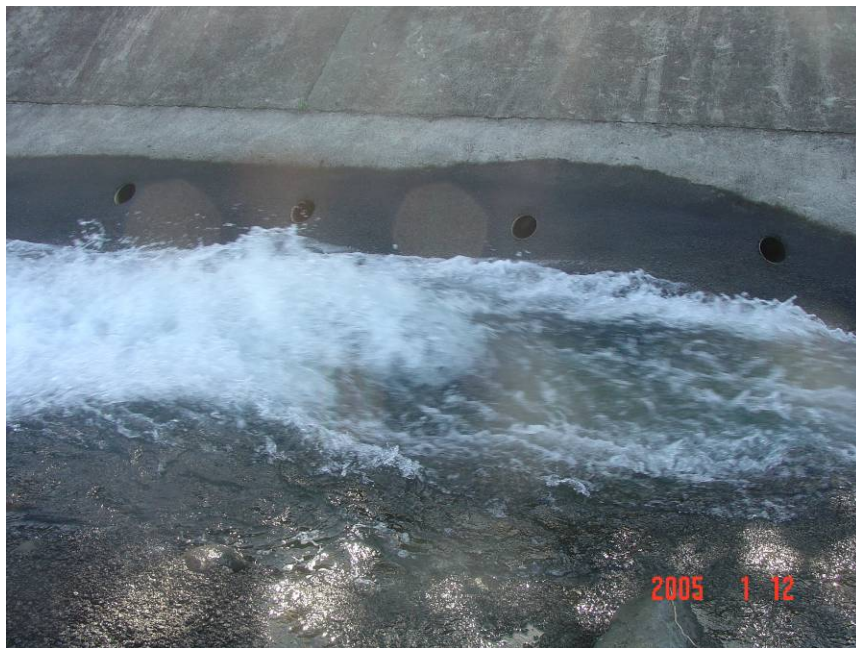
h. Sta. 109+75, Drop Structure #3, verify invert condition. FY04 Photo.

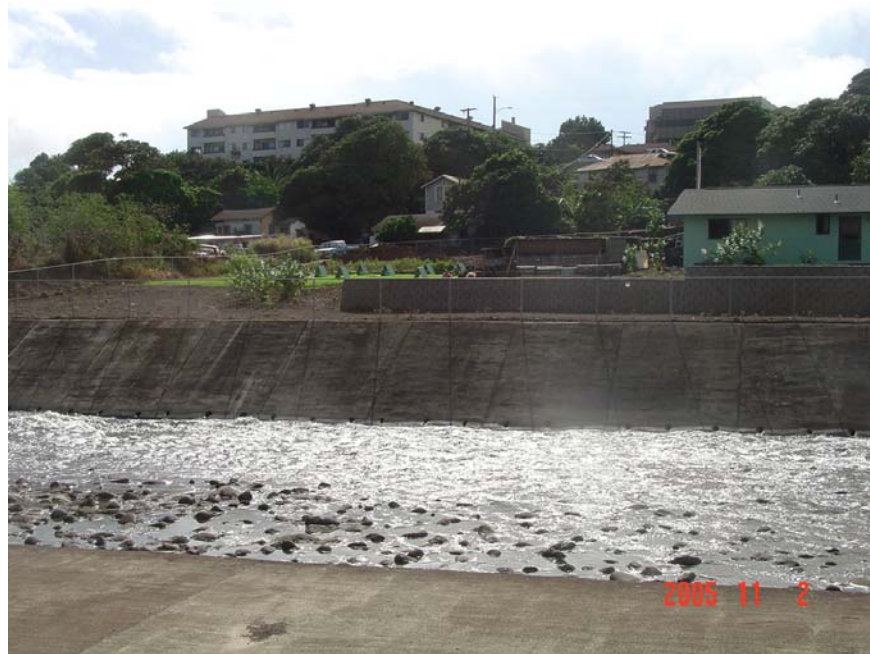
i. Sta. 90+00, RB, good maintenance.

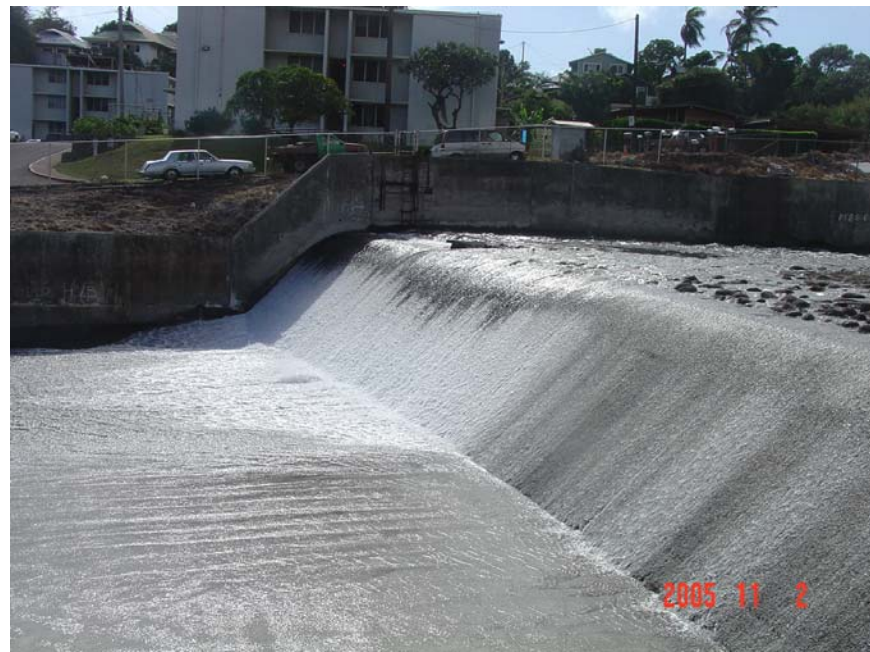
j. Sta. 104.96, Awai drop structure.

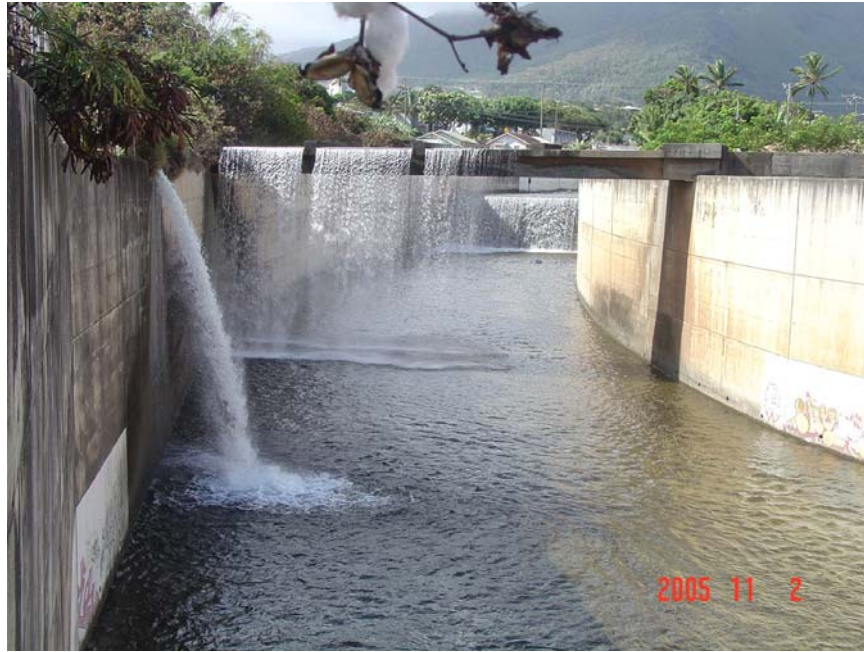
k. Sta. 93+25, RB-side of invert, repair invert.

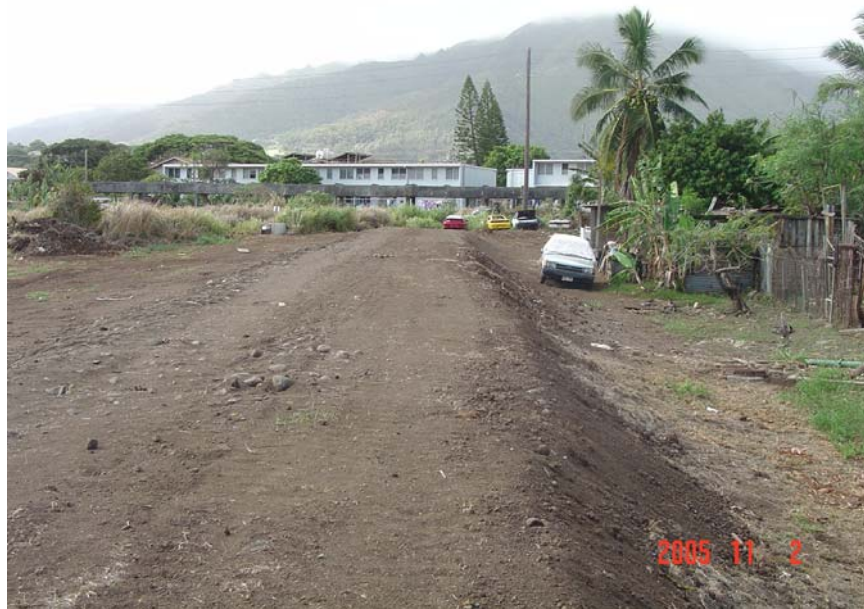
l. Sta. 87+50, LB side of stream, vegetation cleared and unauthorized structure removed.

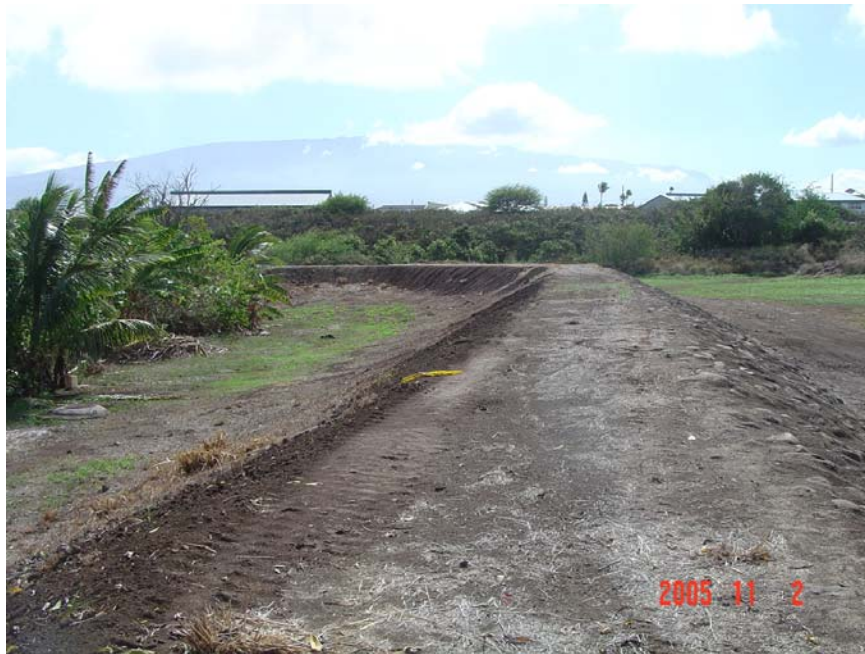
m. Sta. 87+00, Remove trees from interior sideslope of levee G.

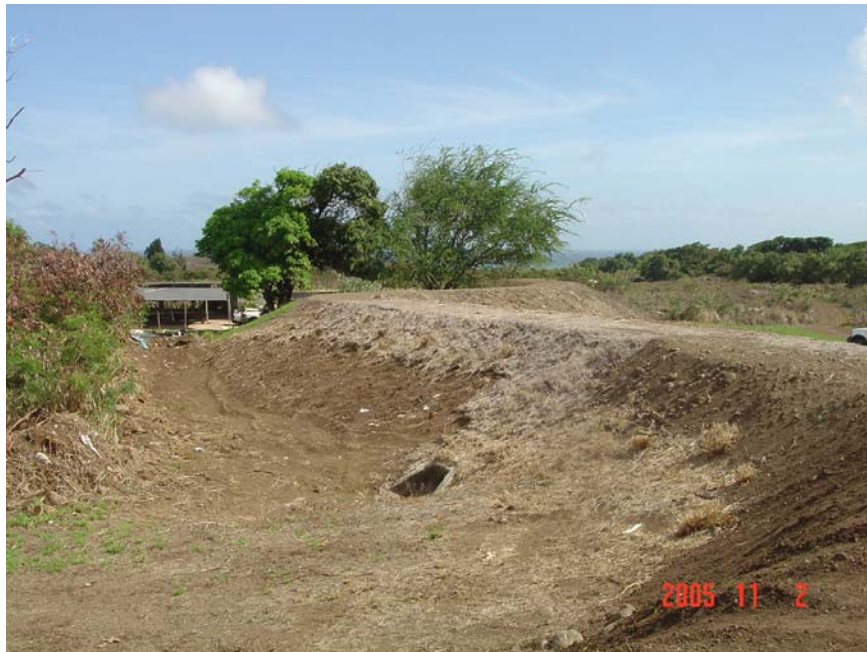
n. Sta. 86+00, woody vegetation removed. Good Maintenance.

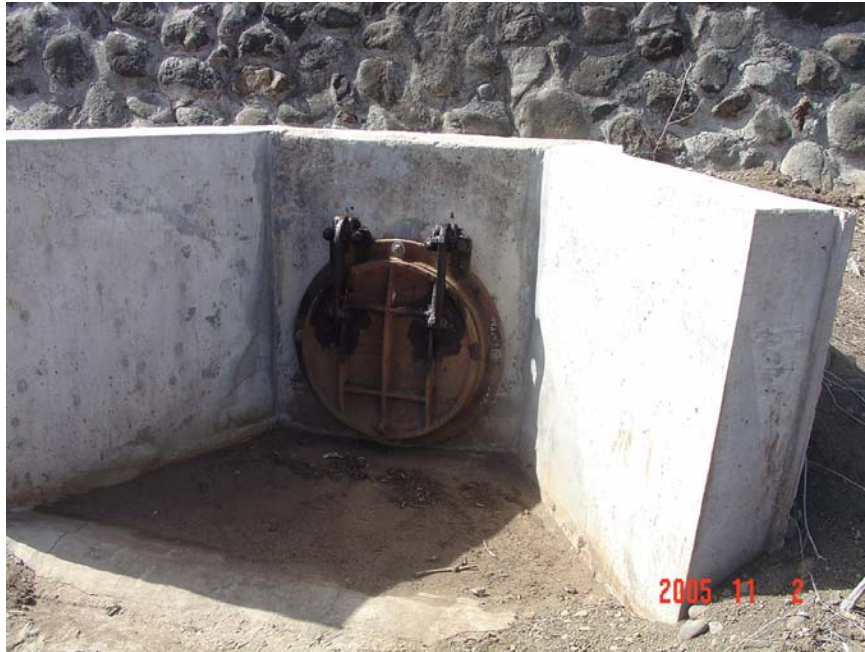
o. Sta. 79+36, Levee G, flapgate in good condition adjacent NRCS Channel.

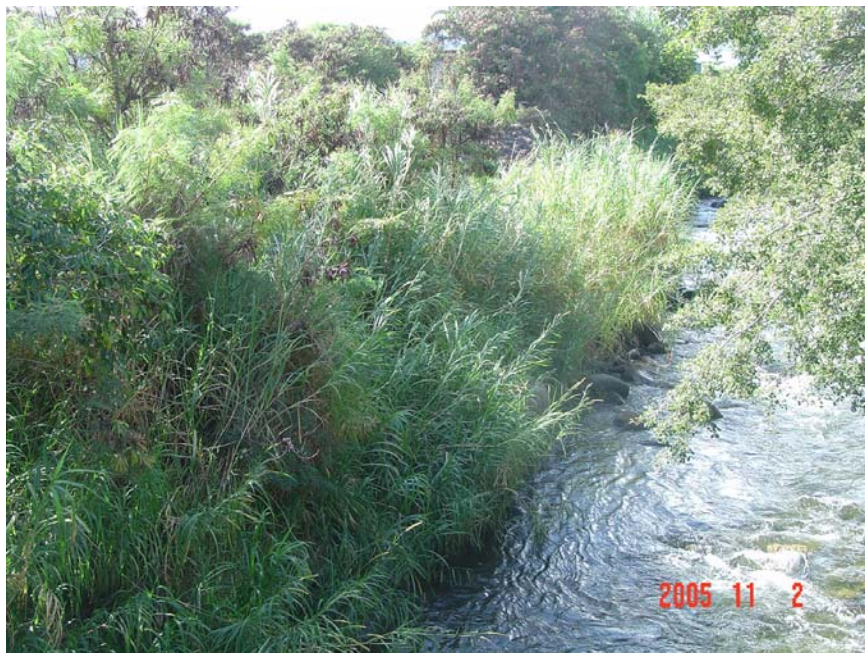
p. Interior Sideslope of levee, pending repairs.

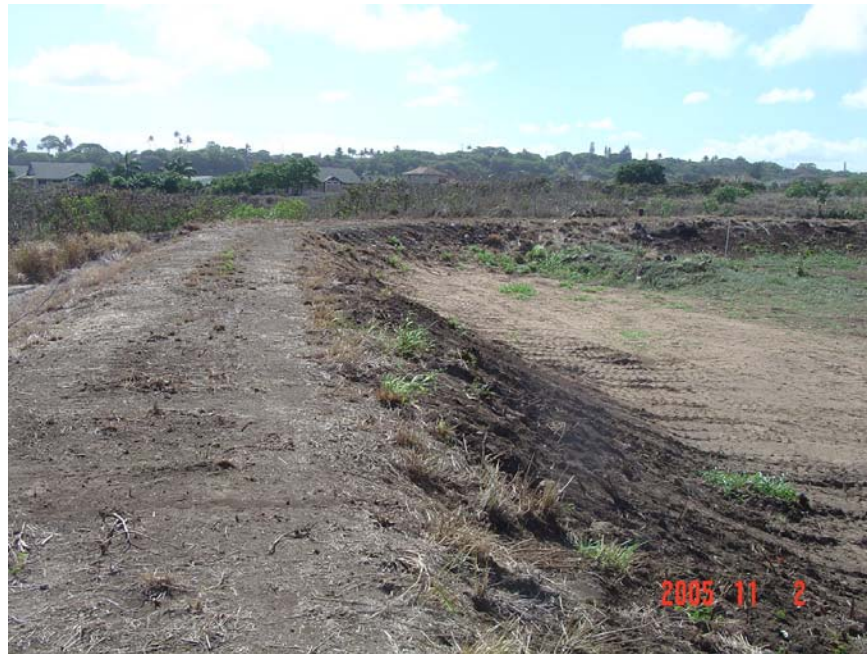
q. Overview, woody vegetation has been removed, continue to maintain sideslope.

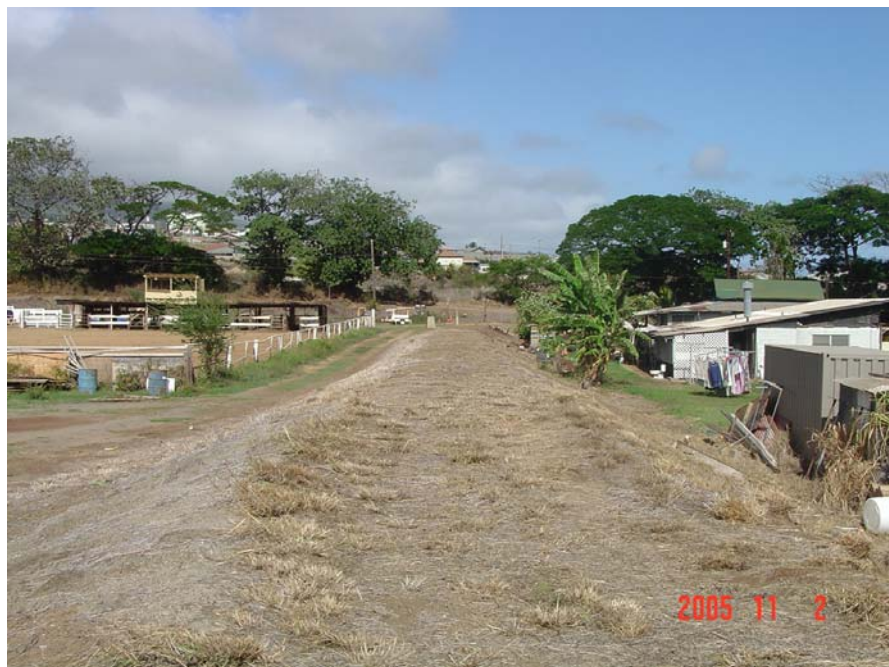
r. Overview, woody vegetation has been removed, continue to maintain sideslope.

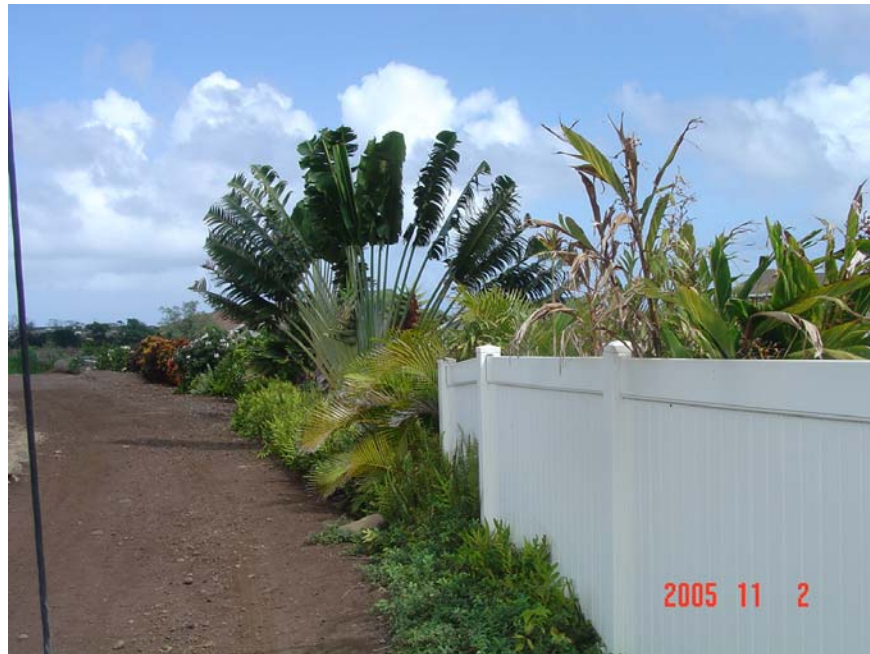
s. Sta. 64+70, RB, monitor this area for vegetation, no woody vegetation permitted.

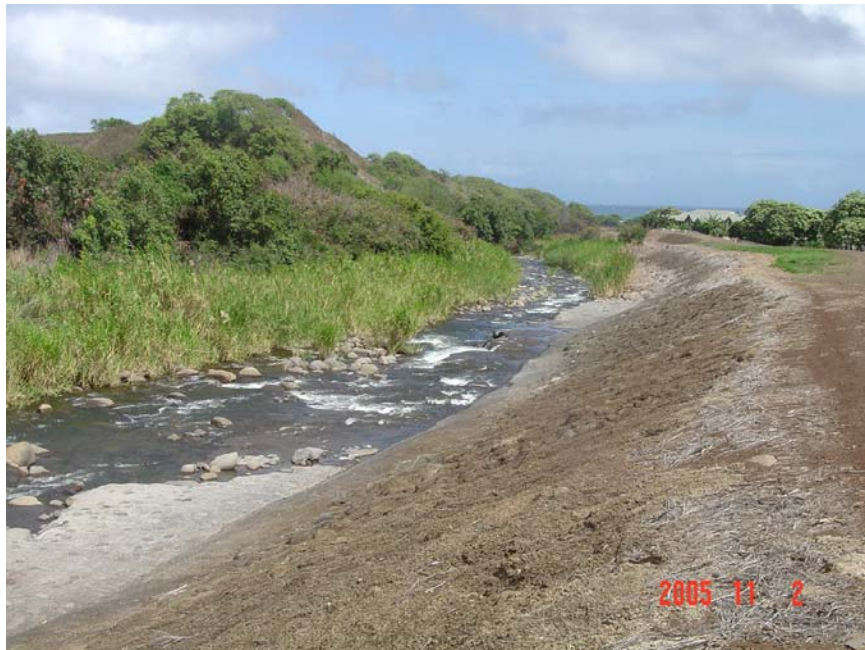
t. Left Bank, New damage from last event. No action required at this time. Pending COE repairs.

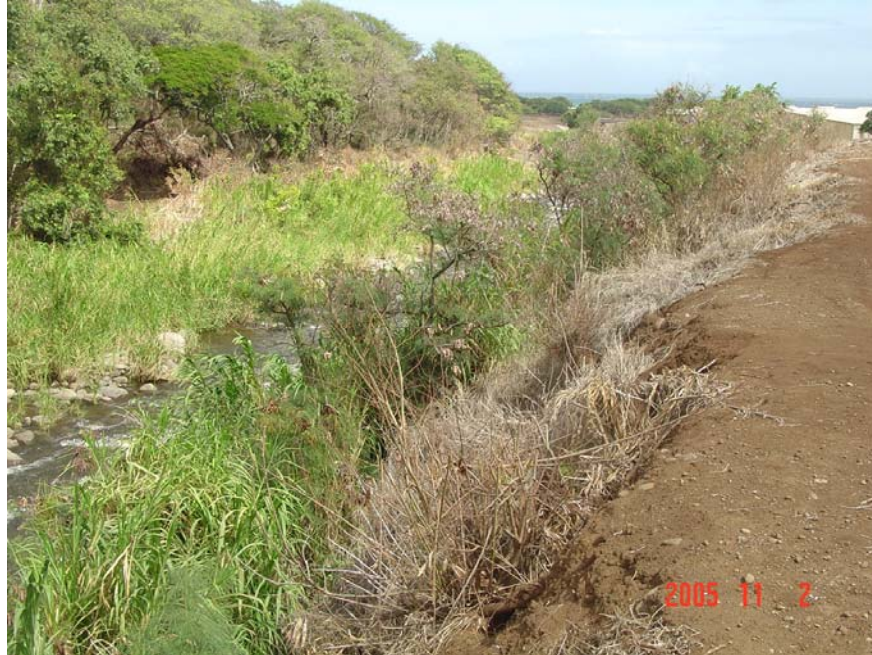
u. Sta. 35+50, RB, Monitor eroding sideslope.

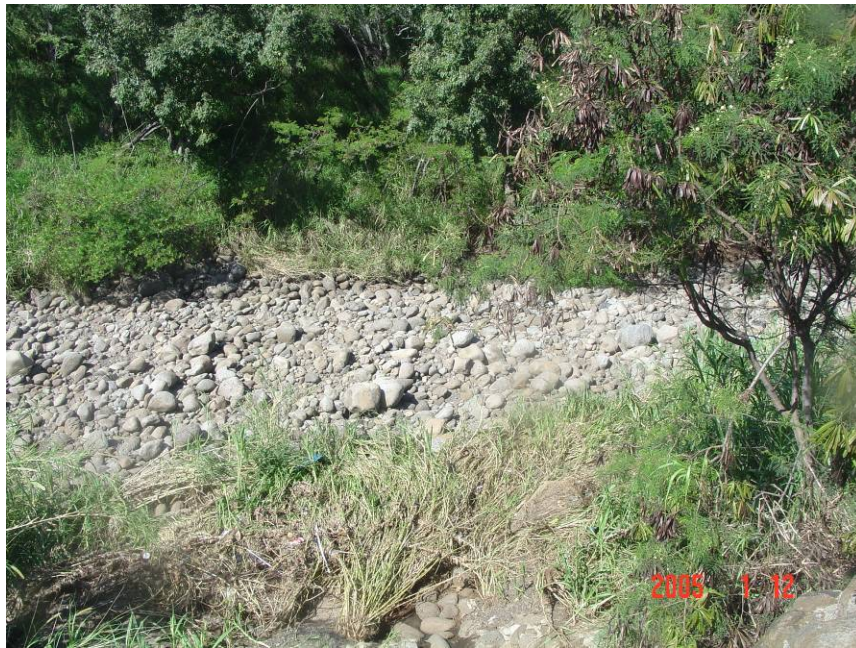
v. Erosion Increasing, FY 05 photo.

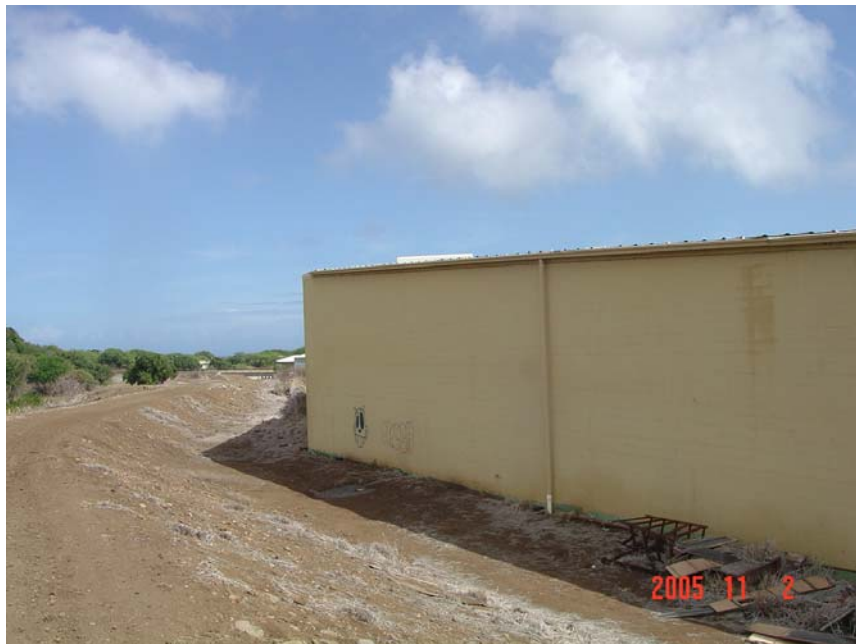
w. Sta. 21+00, RB, vegetation has been removed from the townside of levee B.

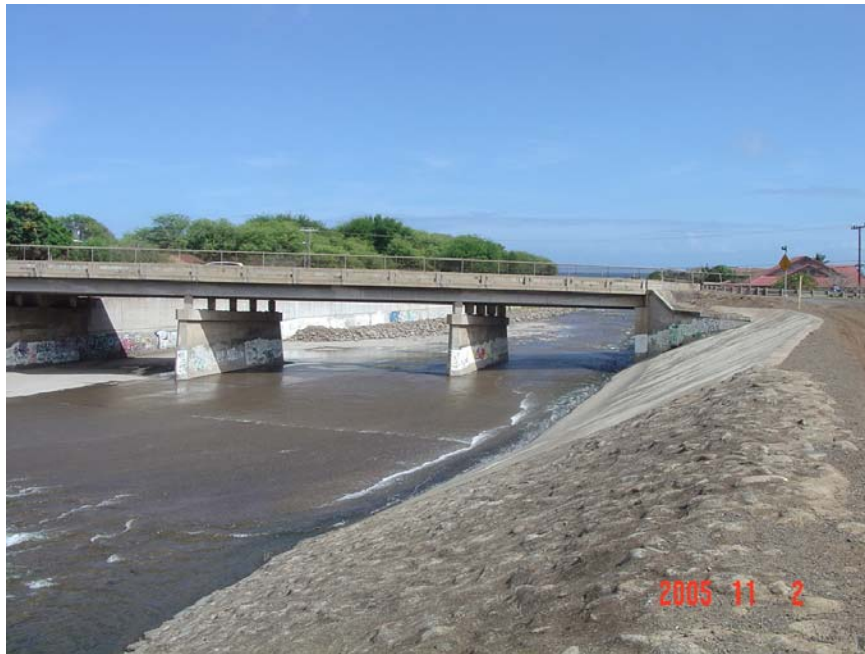
x. Sta. 19+65, RB, rocks and vegetation are being removed under Waiehu bridge and beyond.

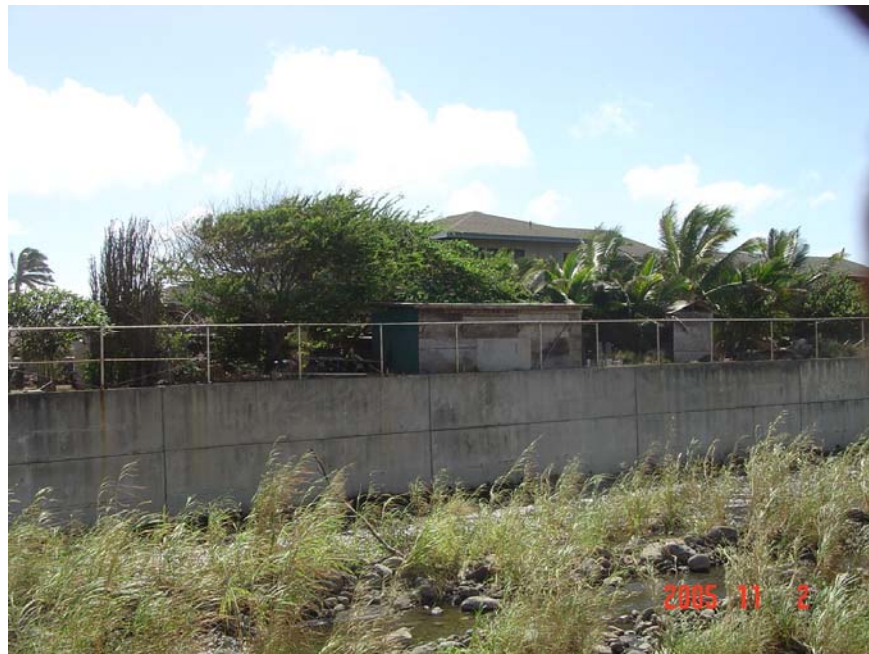
y. Approximate Sta. 19+50, RB, continue to remove rocks and vegetation from channel bottom.

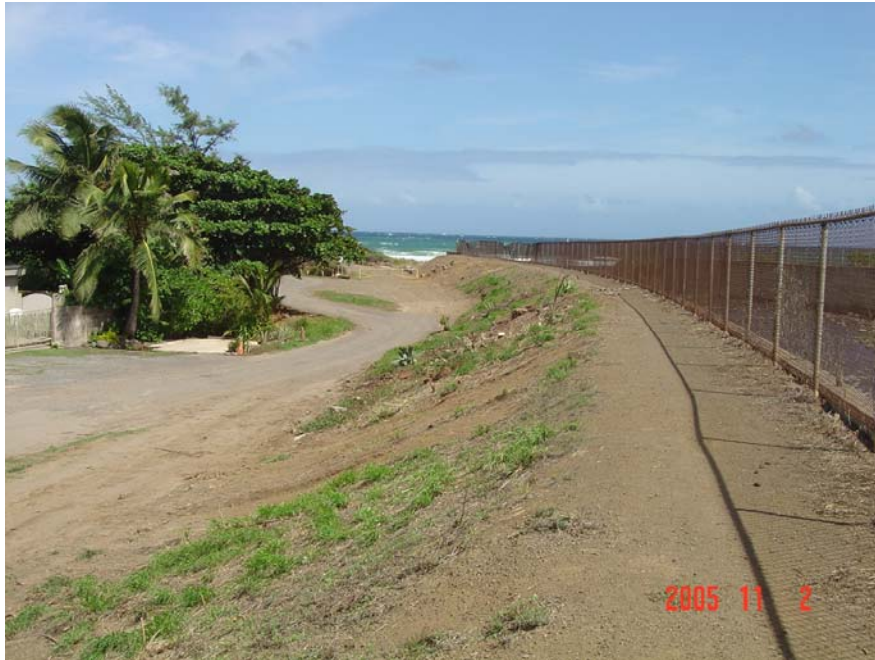
z. Approximate Sta. 4+76, end of channel bottom. Repair fencing on LB channel wall.
